Technical Bulletin

46 07 03 July 6, 2007 **2015173** Supersedes T. B. Group 46 number 07-01 dated June 11, 2007 due to updated warranty table information.

Brake Disc, Pulsation

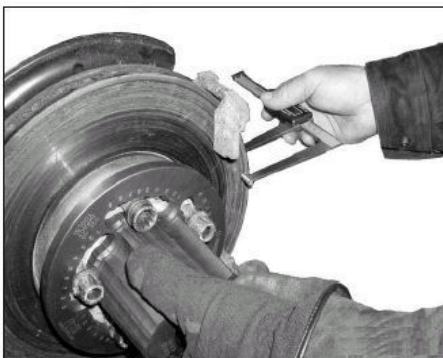
Brake Disc Inspection

- Inspect brake disc friction surfaces on both sides of the brake disc for:

Severe discoloration (blueing)

High heat surface damage (raised hard spots)

Visible cracks

Brake discs showing any of the above described conditions **MUST** be replaced.

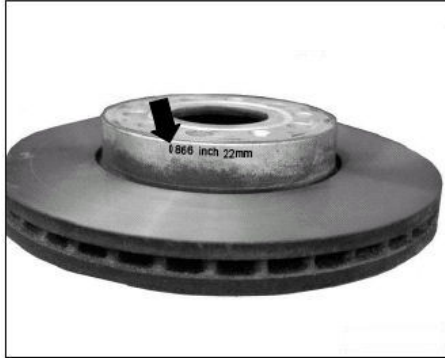
Disc Thickness Measuring

Each brake disc has the minimum allowed thickness cast, stamped or laser-etched into the disc hub.

- Measure the brake disc thickness in 4 locations using either the Pro Cut International™ disc thickness measuring tool Part No. 50-902 or the Hunter Engineering Company disc thickness measuring tool Part No. 25-99-2 . Measurements **MUST** be taken the same distance from the brake disc outer circumference to ensure consistency.

The brake disc must exceed the minimum thickness after the machining process is completed in order to be reused.

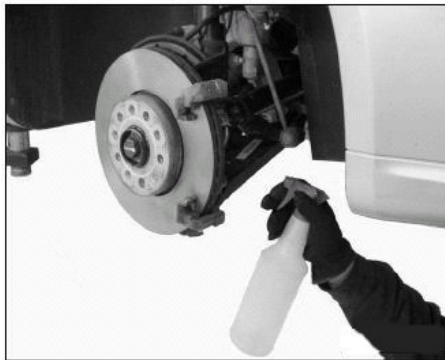
Brake Disc Machining

Recommended on-car brake lathes are either the PRO-CUT International™ PFM 9.0. or the Hunter Engineering Company model OCL 400. This design of brake lathe will produce a surface quality which will provide proper brake performance without a brake pad to brake disc break-in period.

- Follow the brake lathe manufacturer's instructions for set-up and machining.
- Wash the brake disc with a soap and water solution upon completion of resurfacing to remove all machining particles.

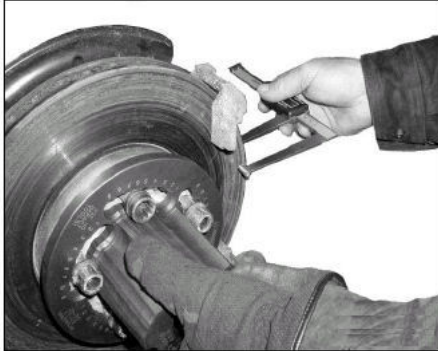
- Re-measure brake disc thickness in 4 locations using either the Pro Cut disc thickness measuring tool Part No. 50-902 or the Hunter disc thickness measuring tool Part No. 25-99-2, to verify that minimum thickness is still exceeded. If recorded brake disc measurement is less than the minimum thickness, the brake disc **MUST** be replaced.

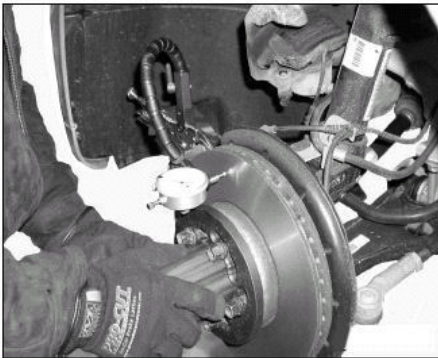
- Measure brake disc lateral run out using Pro Cut Disc Lateral run out measuring kit Part No. 50-700FC or the Hunter Disc Lateral run out measuring kit Part No. 25-128-2 with a dial indicator.
- Run out must be below .05mm.
