OEM SUMMARY GUIDE

A10 WARTHOG W/ GYR Upgrade Package

Pro-Cut OEM Summary

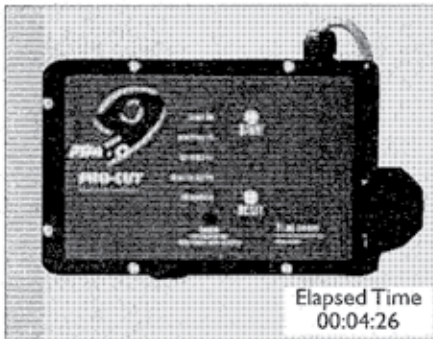
Elapsed Time
00:04:26

Third Step
Press the start button and the machine automatically fully compensates for hub run-out.

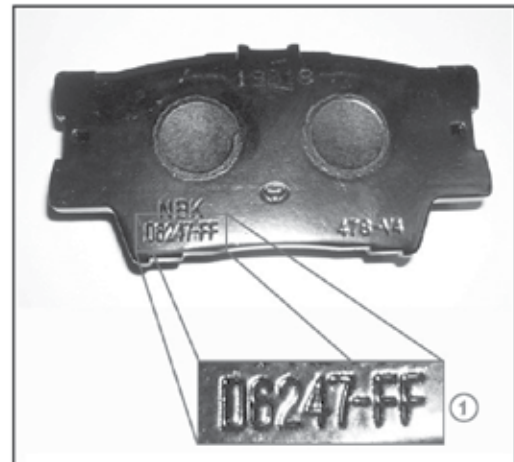
Figure 1.

2. Replace the front brake pads with the improved kit. Visually inspect the shims for heat discoloration. If discolored, replace the shims.
3. Remove the rear pads and check the pad material code on the lower left corner of the pad backing plate (see figure 1).
 - If the code is D6247-FF, do not replace the rear brake pads.
 - If the code is NOT D6247-FF, replace the rear brake pads.

1 Friction Material Code = D6247-FF
